DOSSIER ON MATERIAL TECHNOLOGY AND NON-DESTRUCTIVE TESTING

Laborelec's expanding experience in lifetime extension

Laborelec's expanding experience in lifetime extension	p. 1
Extending the lifetime of a power plant	p. 1
Bundling knowledge on the ageing of nuclear power plants	p. 2
Innovative repair technique for T91	p. 2
Miniature probe used to inspect turbine blades	p. 3
New materials for Ultra Supercritical power plants	p. 3
Safe operation of CVC pumps at Tihange 1	p. 4
Joining manufacturers in root cause analysis	p. 4

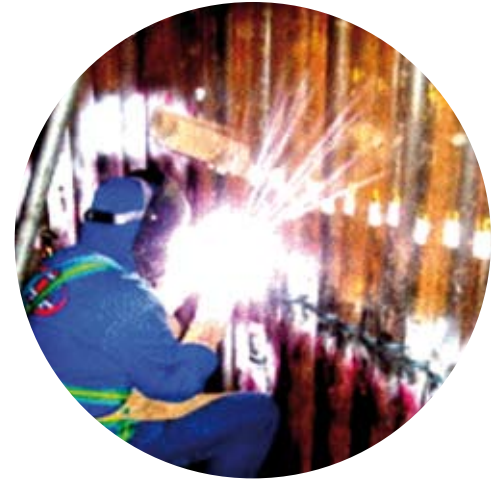
Laborelec developed an innovative repair technique for 9% chrome tubes (T91) used in power plant boilers and steam turbines. This technique enables our team to reduce repair time, minimizing the plant's shutdown and production loss.

The Laborelec methodology is based on the use of a well-defined temper bead technique as an alternative to Post-Weld Heat Treatment (PWHT). As a result our team was able to save time while tempering the martensite. Laborelec however, first had to overcome a number of difficulties. For instance, without PWHT, hardness increased to 440 Vickers, while the norm without PWHT is 350. Gleeble simulations revealed that an increase in pre-heat temperature from 150°C to 250°C decreased hardness by 20 to 30 Vickers. In addition, applying the temper bead technique still required a post-bake at 650°C for 10 to 15 minutes to realize the same conditions as with PWHT. This prolongs the repair time and is difficult to control in practice. Laborelec discovered that optimizing the temper bead technique enables the avoidance of both the increased pre-heat temperature and the application of a post-bake. Currently, Laborelec is fine-tuning the temper bead technique. Mechanical tests are ongoing.

The use of a rather expensive purging and backing technique hampers the repair process. But materials containing more than 9% chrome require inert gas backing to prevent oxidation. By using low alloy T22 — a tube containing only 2.25% chrome — Laborelec is able to avoid such inert gas backing, while keeping the risk of oxidation low. T22 however, has the disadvantage of having rather low creep strength. Laborelec therefore decided to select a modified T24 — 2.25% chrome micro-alloyed with vanadium, titanium, and boron — in the weld. This brings the weld's creep strength close to that of (new) T91, ensuring high quality repairs. Further testing in order to qualify the procedure is ongoing.

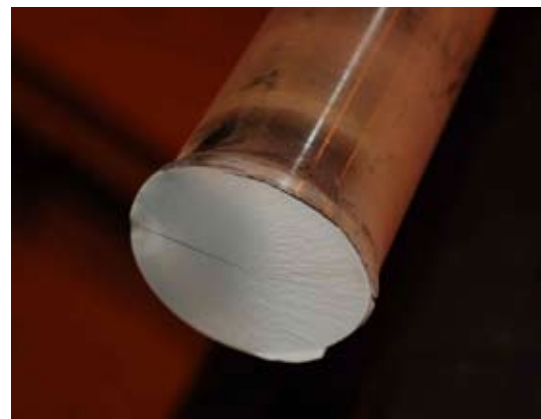
Recently, Laborelec collaborated in a root cause analysis of a turbine through bolt failure at a gas turbine in the United States. Our team assisted the manufacturer of the turbine in every step of the project – from collecting debris to investigating the damaged parts in the manufacturer's laboratories. This hands-on approach was greatly appreciated by the manufacturer who understood that our team is helping them make progress. And that this in turn helps them offer their customers an even better service.

Laborelec can bank on a multidisciplinary team of specialized engineers. The root cause of a problem can occur in many different areas. A damaged turbine through bolt can, for instance, stem from the design of the part, its operational conditions, or the material's composition. Laborelec has experts in every field, working with the latest high-tech research tools in their area of expertise.
