## DOSSIER ON ELECTRICAL EQUIPMENT

### New tightness test on SF6 MV switchgear improves lifecycle calculations

## Identifying shorted turns in generator rotors

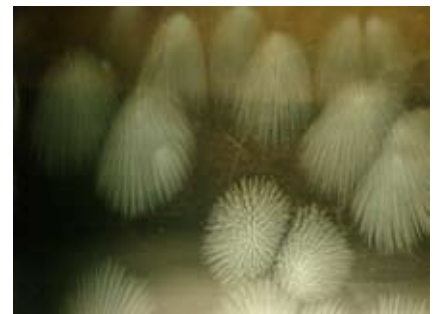
*By accelerating the growth of water trees in laboratories, their evolution can be better understood.*

The most promising method for analyzing water trees is to artificially reproduce the phenomenon using a high frequency, high voltage power source. This enables the acceleration of the process as well as the ability to vary the parameters involved, such as insulation type, environment, and operating conditions. In collaboration with the University of Bucharest, Laborelec has ordered a dedicated power supply unit in the USA, based on specific requirements. Using this equipment, it recently started carrying out accelerated growth tests on real cables (20 kV, 5 kHz). So far the results have been spectacular, with water trees obtained in only seven days in 6 kV cables originating from the Belgian distribution grid. Usually, water trees only appear after twenty to thirty years of service. These encouraging tests on real cables at 5kHz are a world first. The method promises to be extremely useful in timing the replacement and maintenance of existing cables. The technology also presents a potential in terms of resistance tests for new cables.
