DOSSIER ON NATURAL GAS TECHNOLOGIES

Expertise in all aspects of gas technologies

Detection of combustion chamber defect in Saint-Ghislain

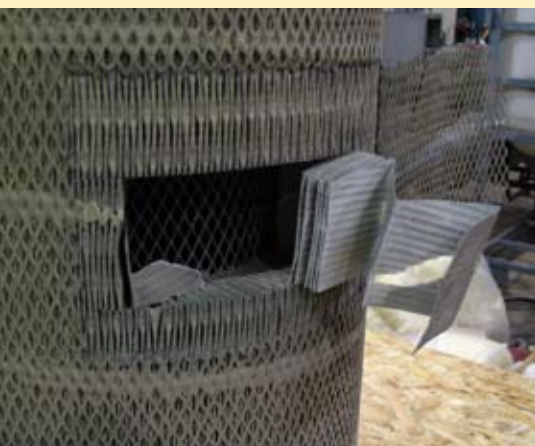
The visual analysis of the Oman filter clearly showed a complete penetration of the filter material.

The history of the Oman filter was unknown, but the visual analysis clearly showed a complete penetration of the filter material. This was due to a prolonged exposure to desert sand, so the filter was not replaced on timely basis.

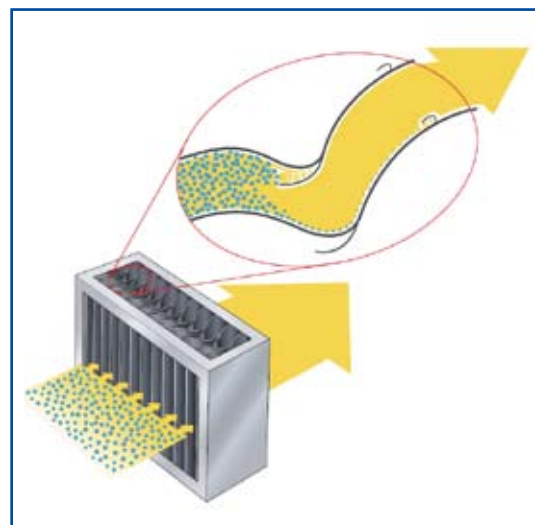
To avoid pressure drops due to fog agglomerating on the filters, a carefully designed droplet catcher should be placed at the filter inlet.

In the Belux climate, filter performance can suffer from fog and rain. Water drops can settle on the filter surface causing large pressure drops. To avoid this, a droplet catcher should be placed at the inlet. Some of the stations examined did not have one; in some others, it was not appropriately dimensioned. We recommend that the droplet catcher always be carefully designed based on geometry and operational parameters of the particular gas turbine.

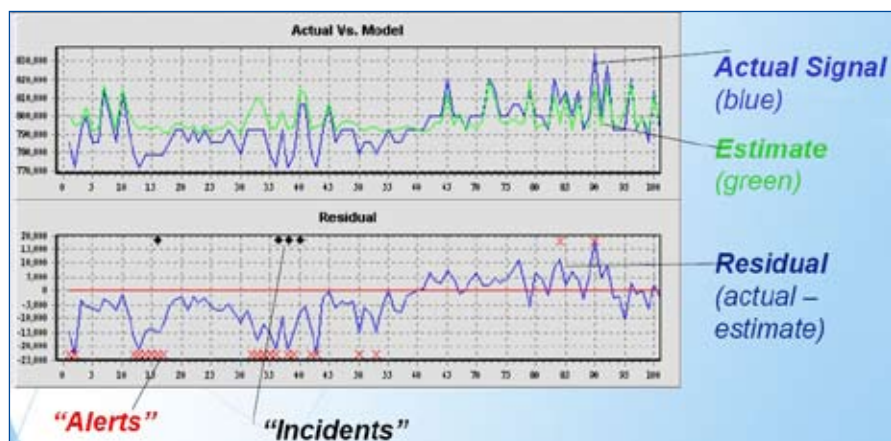
The system generates warnings whenever significant statistical differences arise between measured and expected values. This enables earlier detection of problems than total reliance upon the traditional peak analysis method.

The system collects real-time measurement data from various sources and compares it to statistical models based on historical data. Whenever significant differences arise between measured values and expected values, the system generates warnings. This kind of statistical analysis is much smarter than the detection of peak values.

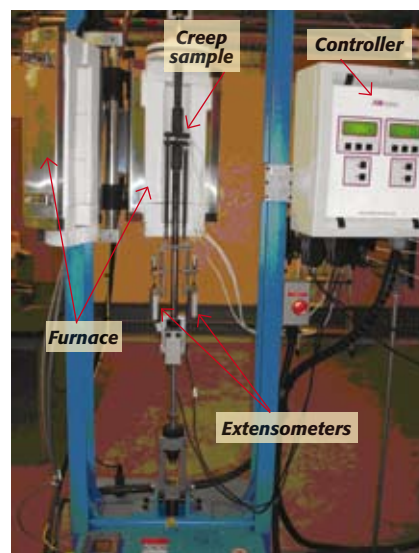
Laborelec has invested in new stress relaxation testing equipment

During conventional creep tests, the samples are exposed to a constant temperature and stress until rupture. This may take from weeks to several months. Laborelec experts can now employ a method to drastically reduce the testing time and without sacrificing the original samples. During stress relaxation tests, testing equipment applies a constant strain at constant temperature. As soon as the sample is strained e.g. 0.5%, the total strain is kept constant and stress is allowed to gradually relax. Monitoring this rate of stress relaxation enables our experts to mathematically calculate the material's creep rate. The entire test only takes a few days.
