## DOSSIER ON CONDITION MONITORING OF ROTATING MACHINERY

### Expert in predictive maintenance for large turbo groups

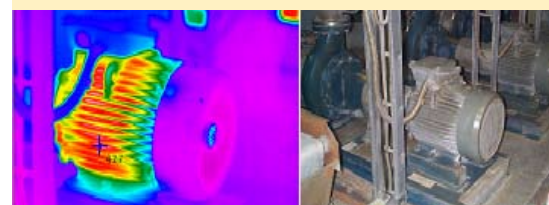
*A thermographic image visualizes temperature differences, identifying potential problems*

During a thermographic analysis, a state-of-the-art infrared camera establishes heat distribution images of electrical and mechanical equipment. These images are then used to identify a wide range of issues such as hot spots, loose connections, corrosion, or worn bearings. The technique does not require any physical contact with the measured equipment, making it especially useful in assessing the state of equipment that is hazardous or difficult to access. The analysis can be performed at distances of up to 200 metres, without any loss of production or downtime. Moreover, repeating the analysis enables the collection of historical data.

Experience is essential in order to generate accurate and reliable results. For instance, the location from which the thermographic picture is taken needs to be chosen with great precision to limit any distortion from the surrounding area. Also the correct emissivity value of the analyzed material is crucial. Laborelec is able to ensure reliable results. Our experts can rely on in-depth training sessions, close collaboration with Electrabel MCC's Predictive Techniques department, and extensive practical experience conducting thermographic scans on a wide range of machinery types. This broad experience enables our experts to accurately make and correctly interpret thermographic images.
