# [ NEWS :

## Focus on natural gas technologies

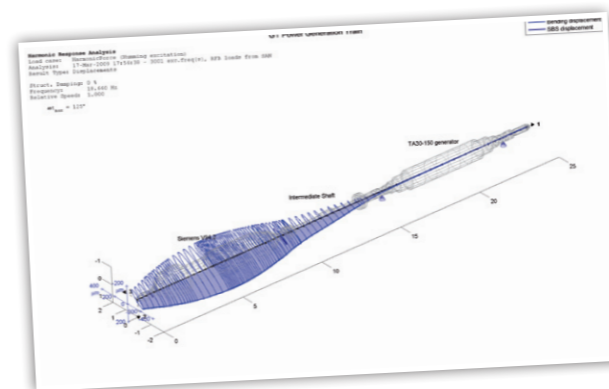
The RDM of the Herdersbrug shaft line reveals that excitations between 18 and 19 Hz lead to high amplitudes and the automatic shutdown of the gas turbine.

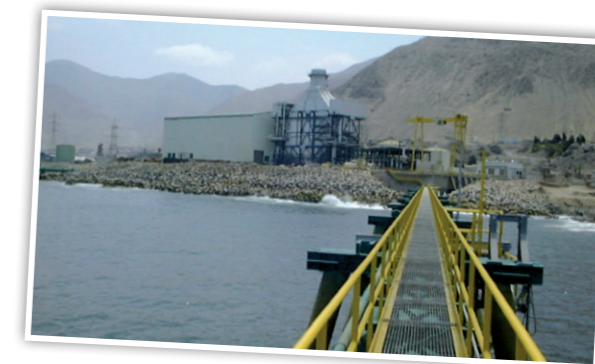
Laborelec assisted a Chilean power plant operator during a root cause analysis of a compressor blade incident.
